ST-500 Probe Troubleshooting Guide

Fouled Probe Causes and Corrective Actions

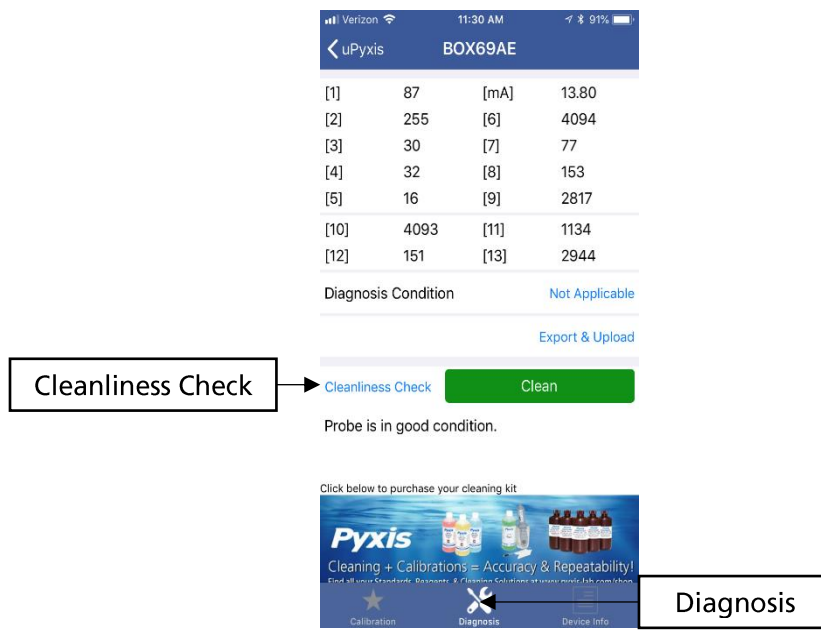
Diagnostics Method: The diagnosis information can be obtained by connecting the ST-500 probe to uPyxis Mobile application or uPyxis Desktop application installed. Connect to the ST-500 probe, then click the **Diagnosis tab**. When in diagnosis screen click the **Cleanliness Check** and the application will let you know if the probe is fouled or in good condition.

The screenshot shows the uPyxis mobile application interface. At the top, it displays the status bar with Verizon, 11:30 AM, and 91% battery. Below the status bar, the app title 'uPyxis' and device ID 'BOX69AE' are shown. A table contains 13 data points:

Below the table, the 'Diagnosis Condition' is listed as 'Not Applicable'. There is an 'Export & Upload' button. A 'Cleanliness Check' button is highlighted with a red box and an arrow pointing to it. Below this button, the text 'Probe is in good condition.' is displayed. At the bottom, there is a section titled 'Click below to purchase your cleaning kit' with a 'Pyxis' logo and a list of products. A 'Diagnosis' tab is highlighted with a red box.
